Town of Arlington, Massachusetts

PART A – Executive Summary Self- Evaluation and Transition Plan

November 2019

Part A – Executive Summary

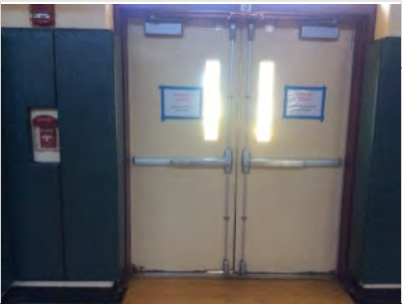
Dispenser acts as a protruding object	-	Relocate dispensers out of the circulation path.	2	353	\$706
Access to Goods and Services												
59	Exit 3	LL		Means of Egress	N/A

Tactile exit sign not provided Illuminated exit sign lacks international symbol of accessibility.	- -	Provide a tactile exit sign with raised characters and braille at the the exit doors. Mount the sign between 48"- 60" above the finished floor to the right side of the right hand door. Provide an illuminated exit sign with the International Symbol of Accessibility (ISA) at accessible exits.	2	116	\$232

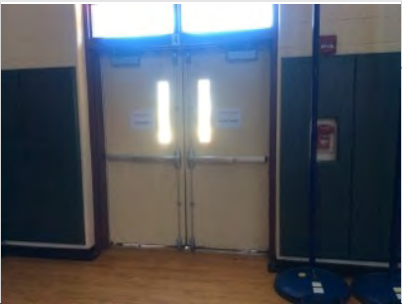
Access to Goods and Services												
60	Exit 4	LL		Means of Egress	N/A

Tactile exit sign not provided Illuminated exit sign lacks international symbol of accessibility.	- -	Provide a tactile exit sign with raised characters and braille at the the exit doors. Mount the sign between 48"- 60" above the finished floor to the right side of the right hand door. Provide an illuminated exit sign with the International Symbol of Accessibility (ISA) at accessible exits.	2	116	\$232

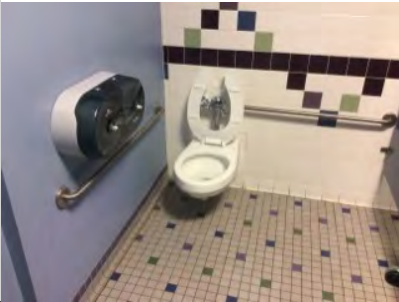
ID	Location	Floor	Room	Element	Type	Photo	Issues	Current Measure	Recommendations	Quantity	Price	Cost Estimation
Toilet Rooms for Children												
61	Girls' Multi-User Toilet Room	LL		Toilet Compartment	Accessible Compartment

Non-compliant toilet paper dispenser	-	Relocate toilet paper dispenser so that it is 14" above the finished floor and between 7"- 9" in front of the toilet. Ensure dispensers and other devices are not mounted above grab bars.	1	353	\$353
62	Girls' Multi-User Toilet Room	LL		Dispensers	Paper Towel Dispenser

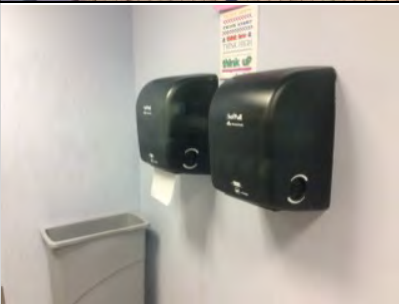
Dispenser acts as a protruding object	-	Relocate dispensers out of the circulation path.	2	353	\$706
Access to Goods and Services												
63	Main Entrance, Exit 5	LL		Means of Egress	N/A

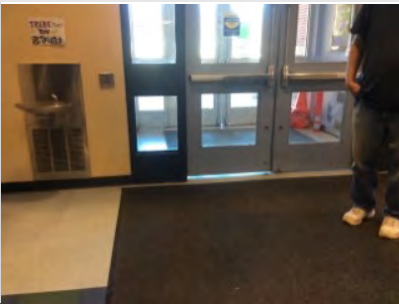
Mat not securely attached Tactile exit sign not provided Illuminated exit sign lacks international symbol of accessibility.	<ul style="list-style-type: none">---	Securely attach mat. Provide a tactile exit sign with raised characters and braille at the the exit doors. Mount the sign between 48"- 60" above the finished floor to the right side of the right hand door. Provide an illuminated exit sign with the International Symbol of Accessibility (ISA) at accessible exits.	2	116	\$232

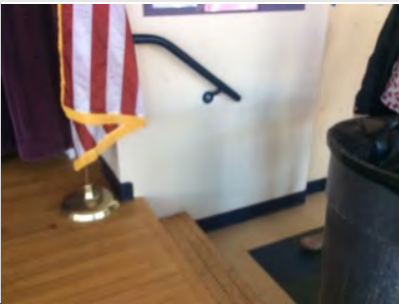
Best Practice												
64	Alternate Route to Stage	LL	023	N/A	N/A

Best Practice: Consider adding an additional railing on the other side of the stairs to allow for greater access.	1	-	\$0

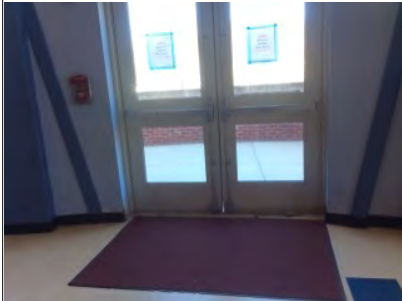
ID	Location	Floor	Room	Element	Type	Photo	Issues	Current Measure	Recommendations	Quantity	Price	Cost Estimation
Access to Goods and Services												
65	Exit 6	LL	023	Means of Egress	N/A

<ul style="list-style-type: none"> Mat not securely attached Tactile exit sign not provided Illuminated exit sign lacks international symbol of accessibility. 	<ul style="list-style-type: none"> - - - 	Securely attach mat. Provide a tactile exit sign with raised characters and braille at the the exit doors. Mount the sign between 48"- 60" above the finished floor to the right side of the right hand door. Provide an illuminated exit sign with the International Symbol of Accessibility (ISA) at accessible exits.	2	116	\$232
Access to Goods and Services												
66	Lift to Stage	LL	023	Doors, Doorways, & Gates	Circulation

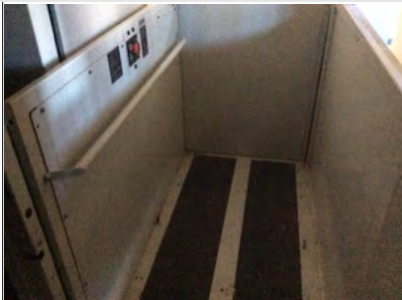
The door to the lift to the stage in the cafetorium is currently very difficult to open independently. IHCD recommends realigning the door at the base of the lift to ensure easier access.

<ul style="list-style-type: none"> Hardware not operable with a closed fist Door requires > 5 lbs. of force to open 	<ul style="list-style-type: none"> - - 	Realign the door at the base of the lift to ensure use by all. It is currently very difficult to open independently at the top level.	1	Labor	\$0

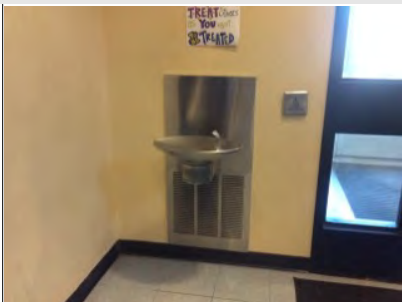
Additional Access												
67	Next to Main Entrance	LL	023	Drinking Fountains	Low

No drinking fountain provided for standing users	<ul style="list-style-type: none"> - 	Provide an additional drinking fountain for standing users.	1	2014	\$2014
Access to Goods and Services												
68	Music Room	LL	031	Interior Access Route	N/A

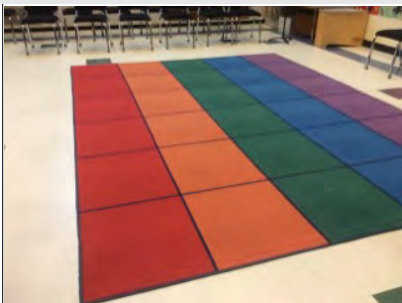
<ul style="list-style-type: none"> Mat not securely attached 	<ul style="list-style-type: none"> - 	Securely attach mat.	1	Labor	\$0

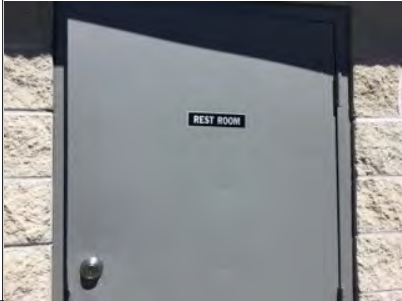
ID	Location	Floor	Room	Element	Type	Photo	Issues	Current Measure	Recommendations	Quantity	Price	Cost Estimation
Access to Goods and Services												
1	Single-User Toilet Room	1		Signage	Designation

Raised characters not provided Braille not provided Sign not located on the latch side of the door International Symbol of Acc. not compliant		Provide text with raised characters duplicated in braille. Locate sign at permanent rooms alongside the door on the latch side. At the toilet room that is renovated, ensure that the sign contains the International Symbol of Accessibility.	2	116	\$232
Toilet & Bathing Rooms												
2	Single-User Toilet Room	1		Single-User Toilet	N/A

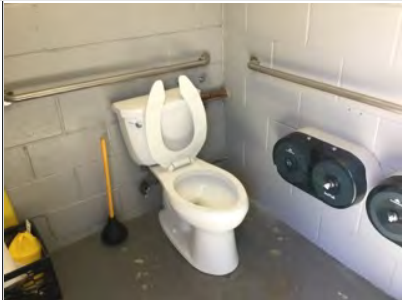
Centerline < or > 18" (MAAB)	20"	At one toilet room, relocate toilet so that the centerline is 18" from the side wall.	1	1414	\$1414
3	Single-User Toilet Room	1		Dispensers	Soap Dispenser

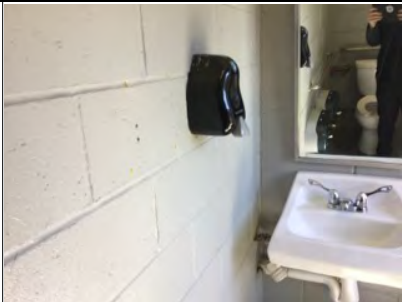
Controls > 42" high	50"	At one toilet room, relocate soap dispenser so the operable part is 42" max. above the finish floor.	1	353	\$353

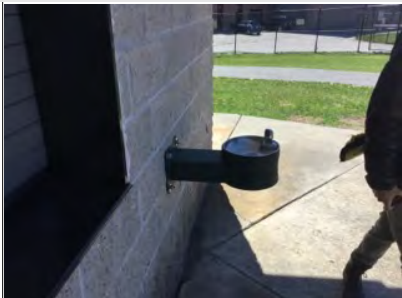
Additional Access												
4	Concession Counter Drinking Fountain	Ext.		Drinking Fountains	Low

No drinking fountain provided for standing users		Provide an additional drinking fountain for standing users.	1	2014	\$2014

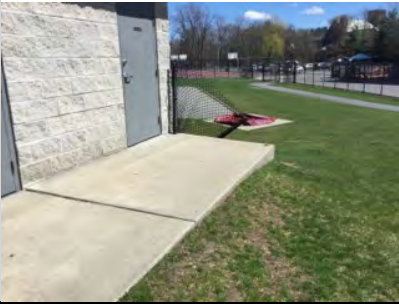
Best Practice: Consider providing edge protection at the edge of the concrete surface to prevent falls.	1		\$0
Approach and Entrance												
6	Route to Basketball Courts	Ext.		Exterior Access Route	Exterior

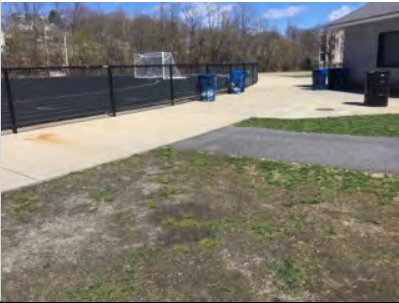
The transition between the asphalt surface and the concrete surface leading to the basketball courts needs repair.

Surface is not stable, firm, and slip-resistant		Repair surface at transition between asphalt and concrete.	1	103	\$103

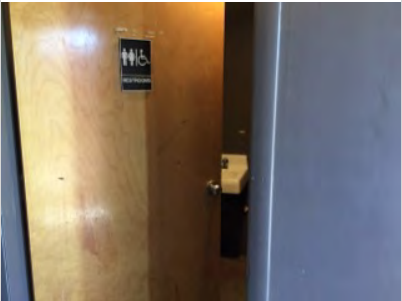
ID	Location	Floor	Room	Element	Type	Photo	Issues	Current Measure	Recommendations	Quantity	Price	Cost Estimation
Access to Goods and Services												
1	Accessible Toilet Room	1		Doors, Doorways, & Gates	Toilet Room

Hardware not operable with a closed fist		Provide hardware that can be operable with one hand and not require tight grasping, pinching, or twisting of the wrist.	1	242	\$242
2	Accessible Toilet Room	1		Signage	Designation

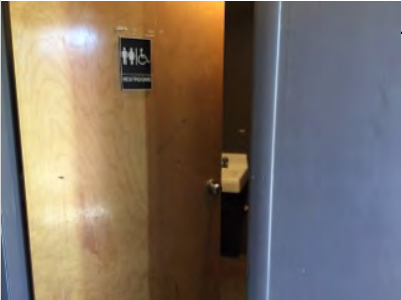
. Sign not located on the latch side of the door		Locate sign at permanent rooms alongside the door on the latch side.	1	Labor	\$0
Toilet & Bathing Rooms												
3	Accessible Toilet Room	1		Single-User Toilet	N/A

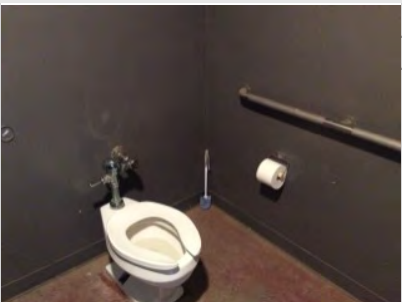
Centerline < or > 18" (MAAB) Rear grab bar > 42" long	29" -	Relocate toilet so that the centerline is 18" from the side wall. Provide a rear wall grab bar that is 42" long min. and extends from the toilet 12" min. on one side and 24" min. on the other side (open side).	1	1863	\$1863

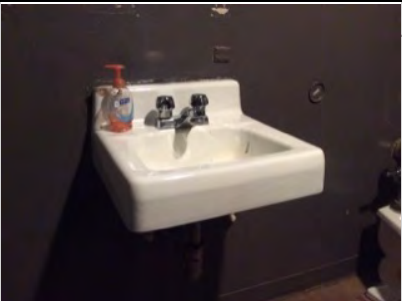
4	Accessible Toilet Room	1		Lavatory	N/A

Faucet is not operable with a closed fist Plumbing underneath is exposed		Provide a faucet that can be operable with one hand and not require tight grasping, pinching, or twisting of the wrist for at least one lavatory. Insulate or otherwise configure pipes to prevent contact at lavatory.	1	539	\$539
Additional Access												
5	Drinking Fountain in Toilet Room Vestibule	1		Drinking Fountains	Low

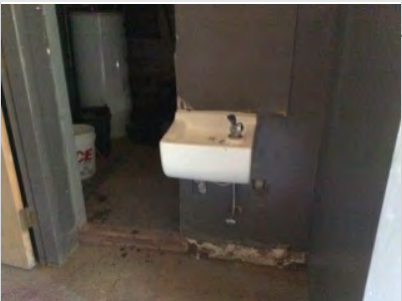
No drinking fountain provided for standing users Knee or toe clearance not provided	- 22"	Install a Hi-Lo drinking fountain. Ensure that knee and toe clearance is 27" min. high at the drinking fountain for seated users.	1	2108	\$2108

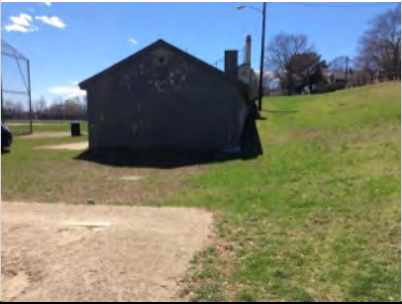
ID	Location	Floor	Room	Element	Type	Photo	Issues	Current Measure	Recommendations	Quantity	Price	Cost Estimation
Approach and Entrance												
6	East Side of Field House	Ext.		Entrance	Main Entrance

Entrance not on an accessible route		Provide an accessible route to the Field House. Exterior routes are discussed in the 2014 ADA Compliance Study for the Recreation Department.	1	See Other Report	\$0
Approach and Entrance												
7	Entrance to Field House Toilet Rooms	Ext.		Entrance	Main Entrance

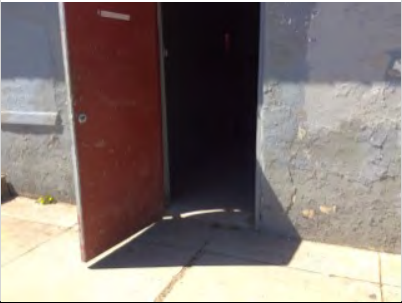
Maneuvering clearance at door > 1:50 (2.00%)	-	Provide an automatic door opener. As best practice consider resurfacing area to reduce the slope.	1	1530	\$1530
Access to Goods and Services												
8	Entrance to Field House Toilet Rooms	Ext.		Signage	Designation

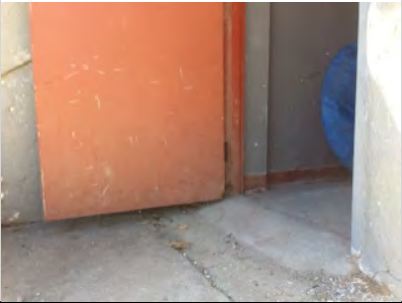
Maneuvering clearance at door > 1:50 (2.00%)	-	Provide an automatic door opener. As best practice consider resurfacing area to reduce the slope.	1	1530	\$1530

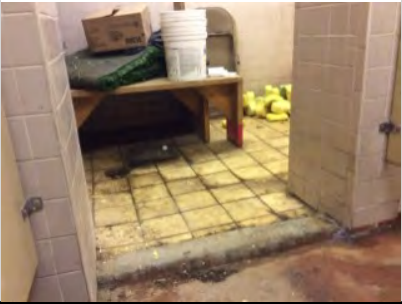
ID	Location	Floor	Room	Element	Type	Photo	Issues	Current Measure	Recommendations	Quantity	Price	Cost Estimation
Access to Goods and Services												
10	Gang Shower	1		Doors, Doorways, & Gates	N/A

Threshold > 1/2" high	3"	Remove threshold and replace with a 1/2" high max. threshold.	1	159	\$159
Toilet & Bathing Rooms												
11	Gang Shower	1		Shower Compartment	Roll-In Type

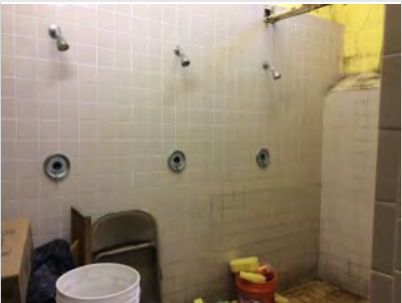
Grab bars not provided		Provide two 42" long grab bars at a corner shower. Ensure the top of the grab bars are located 33" to 36" above the finished floor underneath the shower controls.	2	449	\$898
Access to Goods and Services												
12	Locker Room	1		Locker Room	N/A

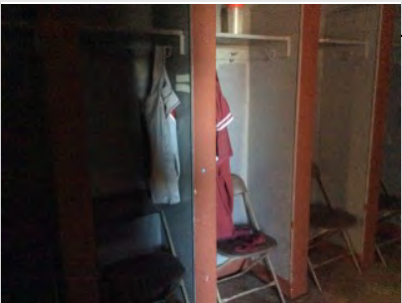
Storage > 48" high Bench not provided	63" -	Ensure that at least 5% of storage area (or 1 storage area is accessible, and with shelves and hooks located no higher than 48 inches above the floor. Provide an accessible bench within the room by the accessible storage area.	1	228	\$228

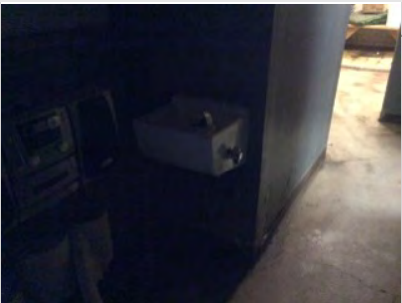
Additional Access												
13	Locker Room	1		Drinking Fountains	Low

No drinking fountain provided for standing users Knee or toe clearance not provided	- 23"	Install a Hi-Lo drinking fountain. Ensure that knee and toe clearance is 27" min. high at the drinking fountain for seated users.	1	2108	\$2108

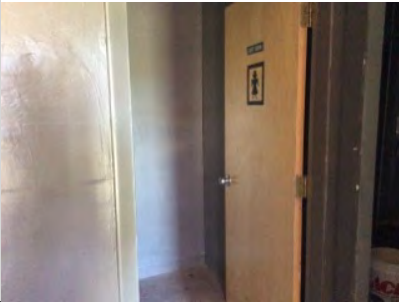
ID	Location	Floor	Room	Element	Type	Photo	Issues	Current Measure	Recommendations	Quantity	Price	Cost Estimation
Access to Goods and Services												
14	Men's and Women's Toilet Rooms	1		Signage	Designation

Raised characters not provided Braille not provided Sign not located on the latch side of the door	- - - -	Provide text with raised characters duplicated in braille. Locate sign at permanent rooms alongside the door on the latch side.	2	116	\$232
15	Men's and Women's Toilet Rooms	1		Signage	Directional

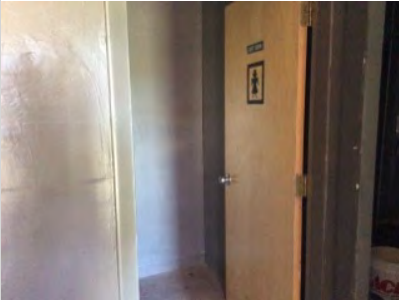
Directional sign to access. toilet not provided	-	Provide a visual sign indicating the location of the nearest accessible toilet room. (Note: Directional sign could be combined with the designation signs mentioned in Record # 14.)	2	-	\$0
Access to Goods and Services												
16	Route to Locker Room From Exterior	1		Interior Access Route	N/A

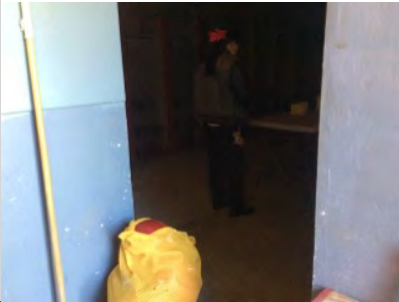
Route < 36" wide	-	Ensure that a clear width of 36" min. is maintained at the accessible route by removing clutter.	1	Labor	\$0

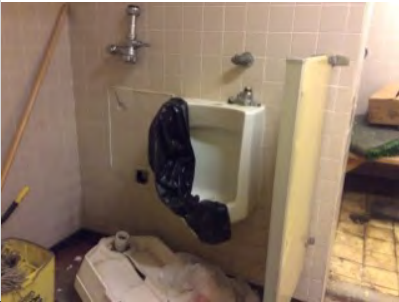
Toilet & Bathing Rooms												
17	Shower Area Urinal	1		Urinal	N/A

Clear floor space not provided at urinal Not maintained	- -	Ensure that urinal is maintained and kept free of debris so that a 30" x 48" clear floor space is provided.	1	Labor	\$0

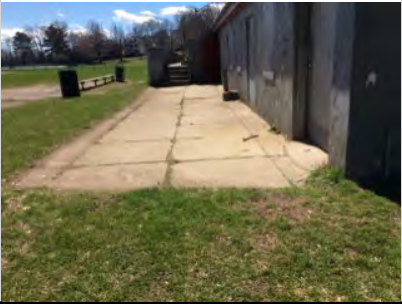
ID	Location	Floor	Room	Element	Type	Photo	Issues	Current Measure	Recommendations	Quantity	Price	Cost Estimation
Approach and Entrance												
18	South Side of Field House, Location of Main Entrances	Ext.		Exterior Access Route	Walkway

Level changes > 1/4" Surface is not stable, firm, and slip-resistant	- -	Repair concrete surface to be firm stable and slip-resistant and address any changes in level greater than 1/4" high. (Cost estimate for resurfacing a 50' long concrete area.)	1	250	\$250
Best Practice												
19	South Side of Field House, Location of Main Entrances	Ext.

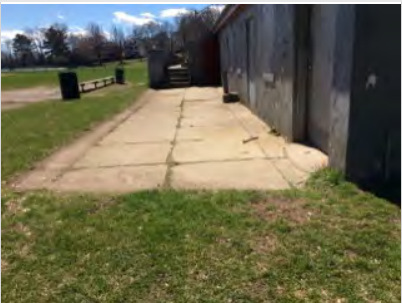
Best Practice: Consider raising the height of this concrete surface during renovations to help lessen the excessive slopes at door thresholds.	1		\$0
Access to Goods and Services												
20	Toilet Room by Shower Area	1		Signage	Directional

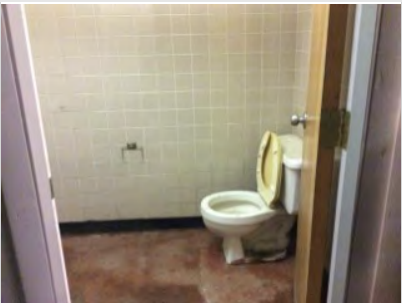
Directional sign to access. toilet not provided		Toilet room is not accessible. Provide a sign indicating the location of the nearest accessible toilet room.	1	116	\$116

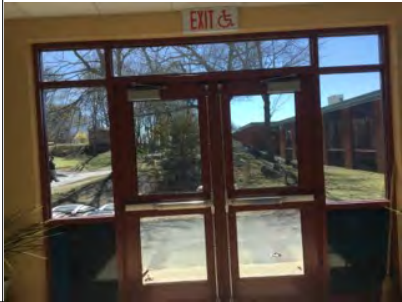
ID	Location	Floor	Room	Element	Type	Photo	Issues	Current Measure	Recommendations	Quantity	Price	Cost Estimation
Approach and Entrance												
1	Cafeteria Exit	1		Emergency Exit	N/A

Tactile exit sign not provided	-	Provide tactile exit signs with raised characters and braille at exit doors. Mount signs between 48" - 60" above the finished floor on the latch side of the door.	1	116	\$116
Approach and Entrance												
2	Exit by Custodian's Office	1		Emergency Exit	N/A

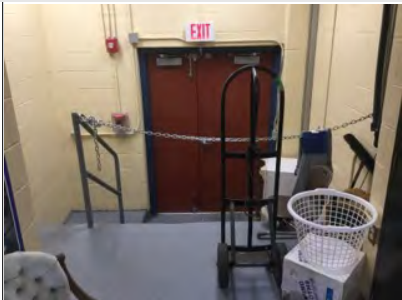
Emergency exit not on an accessible route Directional sign to accessible emergency exit not provided Tactile exit sign not provided	- -	Provide a directional sign indicating the location of the nearest emergency exit. Provide tactile exit signs with raised characters and braille at exit doors. Mount signs between 48" - 60" above the finished floor on the latch side of the door.	2	116	\$232
Approach and Entrance

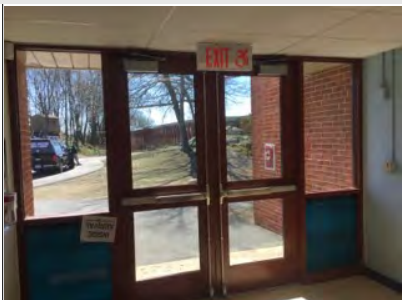
3	Exit Near Kiln Room	1		Emergency Exit	N/A

Tactile exit sign not provided		Provide tactile exit signs with raised characters and braille at exit doors. Mount signs between 48" - 60" above the finished floor on the latch side of the door.	1	116	\$116
Access to Goods and Services												
4	1st Grade Classroom	1	102	Dining or Work Surfaces	Work Surface

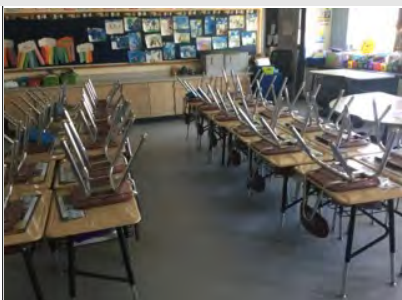
At least one or 5% accessible tables not provided	-	Provide at least one (1) accessible desk with 24" min. knee clearance and 30" min. clear width. Ensure accessible work surfaces are well integrated with class seating plans.	1	350	\$350

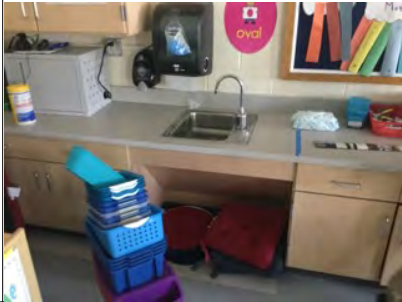
ID	Location	Floor	Room	Element	Type	Photo	Issues	Current Measure	Recommendations	Quantity	Price	Cost Estimation
Additional Access												
5	1st Grade Classroom	1	102	Sinks for Children's Use	Classroom

Knee or toe clearance not provided	24"	Remove items from the clear floor space at the sink.	1	Labor	\$0
Access to Goods and Services												
6	2nd Grade Classroom	1	105	Dining or Work Surfaces	Work Surface

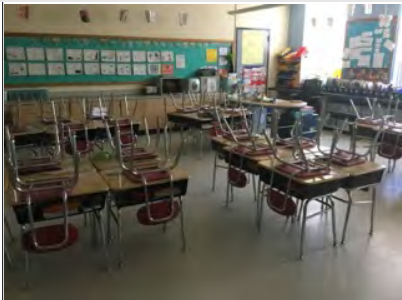
At least one or 5% accessible tables not provided	-	Provide at least one (1) accessible desk with 24" min. knee clearance and 30" min. clear width. Ensure accessible work surfaces are well integrated with class seating plans.	1	350	\$350
Additional Access												
7	2nd Grade Classroom	1	105	Sinks for Children's Use	Classroom

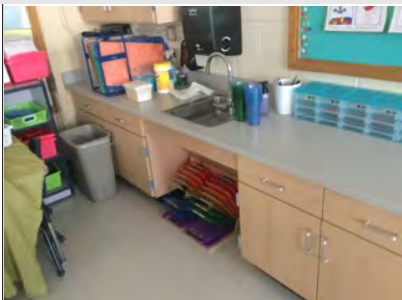
Knee or toe clearance not provided	24"	Remove items from the clear floor space at the sink.	1	Labor	\$0
Access to Goods and Services

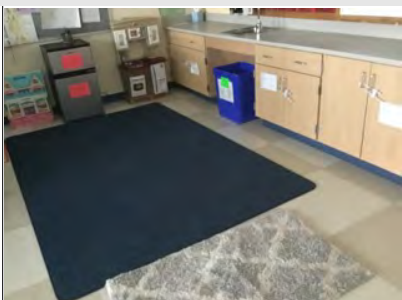
8	Classroom 111	1	111	Interior Access Route	N/A

Surface not stable, firm, and slip-resistant	-	Secure the mat.	1	Labor	\$0

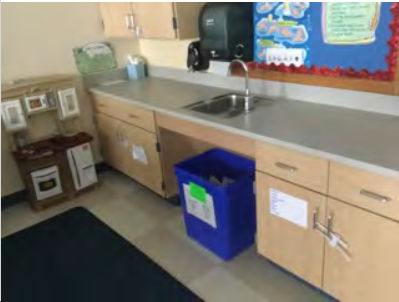
ID	Location	Floor	Room	Element	Type	Photo	Issues	Current Measure	Recommendations	Quantity	Price	Cost Estimation
Additional Access												
9	Classroom 111	1	111	Sinks for Children's Use	Classroom

Knee or toe clearance not provided	-	Relocate recycling bin from the clear floor space at the sink.	1	Labor	\$0
Best Practice												
10	Classroom 111	1	111		Signage

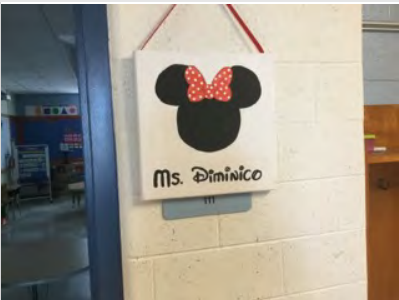
Best Practice		Best Practice: It is strongly recommended not to obstruct compliant signage with homemade non-compliant signage. Relocate non-compliant signs to a new location.	1	-	\$0
Access to Goods and Services												
11	Music Room	1	114	Interior Access Route	N/A

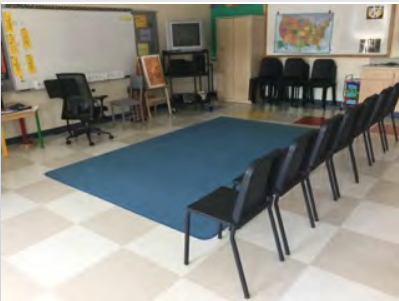
Surface not stable, firm, and slip-resistant	-	Secure the mat.	1	Labor	\$0
Access to Goods and Services												
12	Art Room	1	117	Interior Access Route	N/A

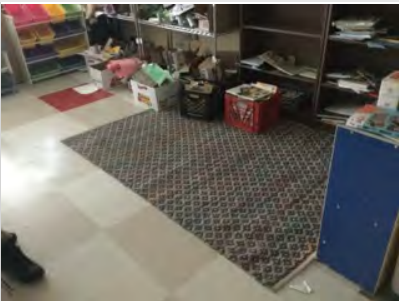
Surface not stable, firm, and slip-resistant	-	Secure the mat.	1	Labor	\$0

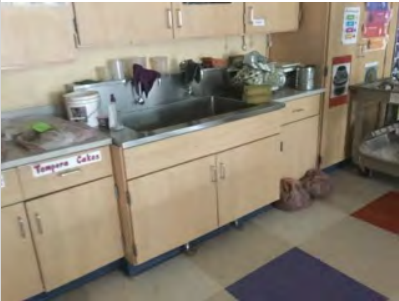
ID	Location	Floor	Room	Element	Type	Photo	Issues	Current Measure	Recommendations	Quantity	Price	Cost Estimation
Additional Access												
13	Art Room	1	117	Sink	Classroom

Toe and knee clearances not provided Rim or counter > 34"	- 38"	Relocate sink with the front of the rim or counter no higher than 34". Ensure there is a 27" knee clearance positioned for a forward approach. If the rim is located no higher than 31" above the finished floor, the knee and toe clearance can be 24" min. per 2010 ADA Standards.	1	2390	\$2390
Access to Goods and Services												
14	Principal's Office	1	124	Dining or Work Surfaces	Work Surface

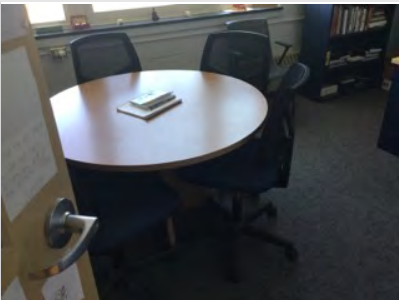
Knee or toe clearance not provided	-	Provide at least 1 work surface with 27" min. knee and toe clearance. Table lacks toe clearance.	1	350	\$350
Access to Goods and Services												
15	Social Worker's Office	1	125	Dining or Work Surfaces	Work Surface

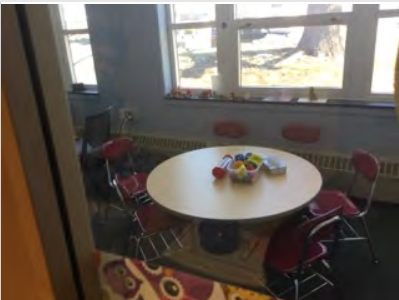
At least one or 5% accessible tables not provided	-	Provide at least 1 work surface with 27" min. knee and toe clearance.	1	350	\$350

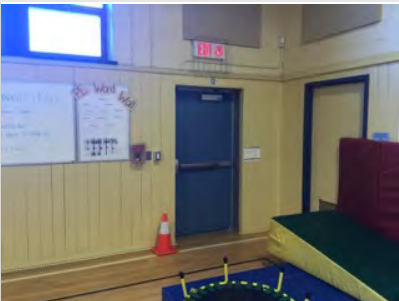
Approach and Entrance												
16	Gymnasium	1	147	Emergency Exit	N/A

Tactile exit sign not provided	-	Provide tactile exit signs with raised characters and braille at exit doors. Mount signs between 48" - 60" above the finished floor on the latch side of the door.	2	116	\$232

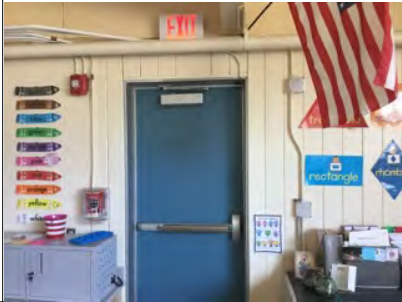
ID	Location	Floor	Room	Element	Type	Photo	Issues	Current Measure	Recommendations	Quantity	Price	Cost Estimation
Approach and Entrance												
17	Kindergarten 3	1	K3	Emergency Exit	N/A

International Symbol of Acc. not provided Tactile exit sign not provided		Provide the International Symbol of Accessibility on the illuminated exit sign. Provide tactile exit signs with raised characters and braille at exit doors. Mount signs between 48" - 60" above the finished floor on the latch side of the door.	2	116	\$232
Toilet & Bathing Rooms												
18	Toilet Room T107	1	T 107	Toilet Compartment	Accessible Compartment

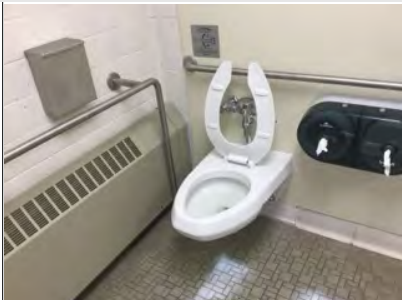
Non-compliant toilet paper dispenser	-	Replace toilet paper dispenser that does not allow continuous paper flow.	1	353	\$353
Toilet & Bathing Rooms												
19	Toilet Room T108	1	T 108	Toilet Compartment	Accessible Compartment

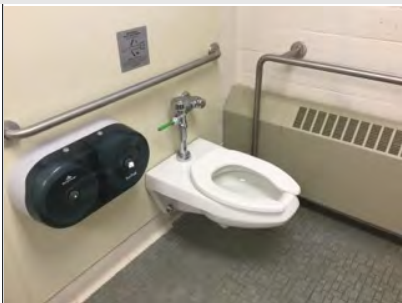
Non-compliant toilet paper dispenser	-	Replace toilet paper dispenser that does not allow continuous paper flow.	1	353	\$353

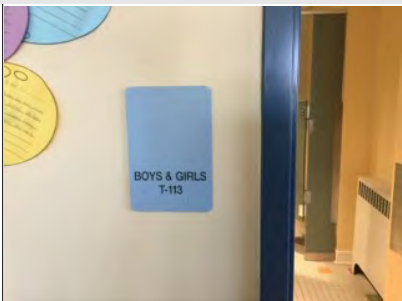
Access to Goods and Services												
20	Toilet Room T113	1	T 113	Signage	Designation

International Symbol of Acc. not compliant	-	Replace sign with a sign containing the International Symbol of Accessibility.	1	116	\$116

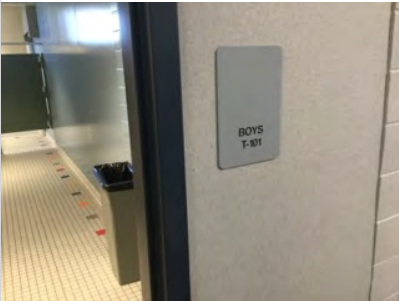
ID	Location	Floor	Room	Element	Type	Photo	Issues	Current Measure	Recommendations	Quantity	Price	Cost Estimation
Access to Goods and Services												
21	Toilet Room T101	1	T101	Signage	Designation

International Symbol of Acc. not compliant	-	Replace sign with a sign containing the International Symbol of Accessibility.	1	116	\$116
Toilet Rooms for Children												
22	Toilet Room T101	1	T101	Toilet Compartment	Accessible Compartment

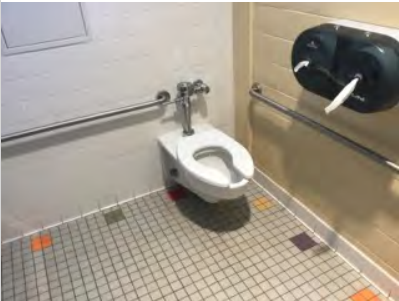
Non-compliant toilet paper dispenser	-	Replace toilet paper dispenser that does not allow continuous paper flow. Relocate toilet paper so that it is 15" min. high, and located under the grab bar.	1	353	\$353
Toilet Rooms for Children												
23	Toilet Room T102	1	T102	Toilet Compartment	Accessible Compartment

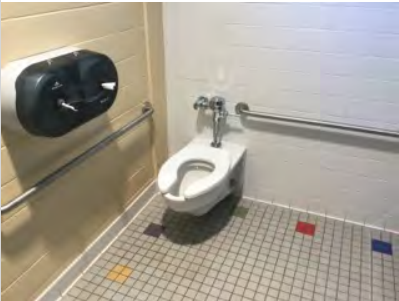
Non-compliant toilet paper dispenser	-	Replace toilet paper dispenser that does not allow continuous paper flow. Relocate toilet paper so that it is 15" min. high, and located under the grab bar.	1	353	\$353

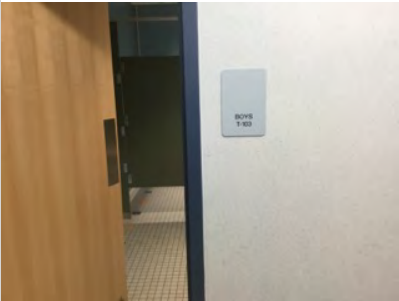
Access to Goods and Services												
24	Toilet Room T103	1	T103	Signage	Designation

International Symbol of Acc. not compliant	-	Replace sign with a sign containing the International Symbol of Accessibility.	1	116	\$116

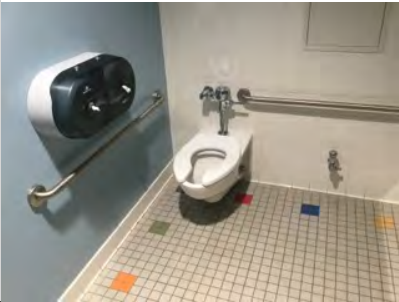
ID	Location	Floor	Room	Element	Type	Photo	Issues	Current Measure	Recommendations	Quantity	Price	Cost Estimation
Toilet Rooms for Children												
25	Toilet Room T103	1	T103	Toilet Compartment	Accessible Compartment

Non-compliant toilet paper dispenser	-	Replace toilet paper dispenser that does not allow continuous paper flow. Relocate toilet paper so that it is 15" min. high, and located under the grab bar.	1	353	\$353
Access to Goods and Services												
26	Toilet Room T104	1	T104	Signage	Designation

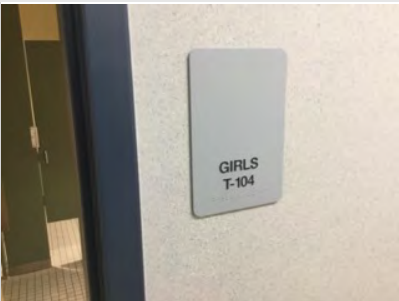
International Symbol of Acc. not compliant	-	Replace sign with a sign containing the International Symbol of Accessibility.	1	116	\$116
Toilet Rooms for Children												
27	Toilet Room T104	1	T104	Toilet Compartment	Accessible Compartment

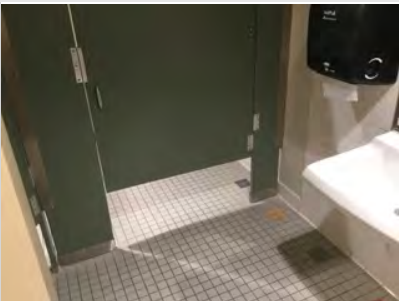
Door with inadequate maneuvering clearance	29"	Remove lavatory to provide adequate maneuvering clearance, or provide sign to accessible toilet. (Cost estimate to remove lavatory.)	1	500	\$500

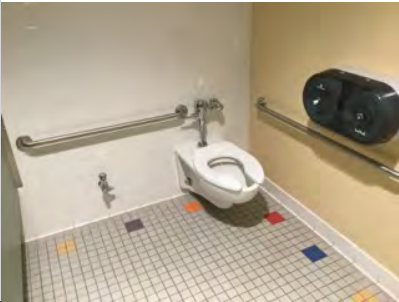
28	Toilet Room T104	1	T104	Toilet Compartment	Accessible Compartment

Non-compliant toilet paper dispenser	-	Replace toilet paper dispenser that does not allow continuous paper flow. Relocate toilet paper so that it is 15" min. high, and located under the grab bar.	1	353	\$353

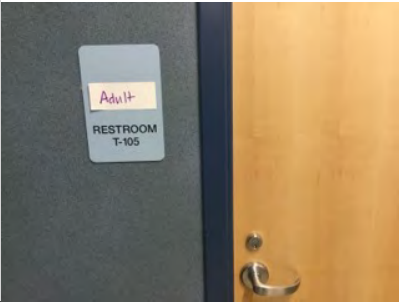
ID	Location	Floor	Room	Element	Type	Photo	Issues	Current Measure	Recommendations	Quantity	Price	Cost Estimation
Access to Goods and Services												
29	Toilet Room T105	1	T105	Signage	Designation

Raised characters not provided International Symbol of Acc. not compliant	- -	Provide text with raised characters duplicated in braille. Replace sign with a sign containing the International Symbol of Accessibility (ISA).	1	116	\$116
Toilet & Bathing Rooms												
30	Toilet Room T105	1	T105	Single-User Toilet	N/A

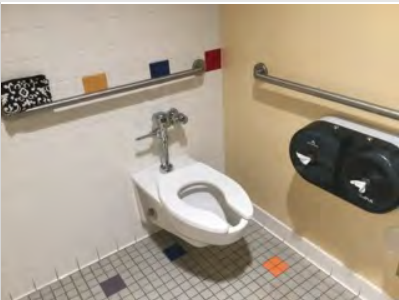
Toilet paper dispenser is not compliant	-	Replace toilet paper dispenser that does not allow continuous paper flow.	1	353	\$353
Access to Goods and Services												
31	Toilet Rooms T108, T109	1	T108	Signage	Designation

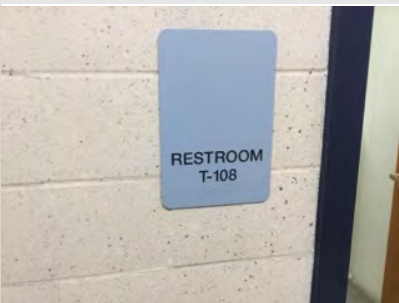
International Symbol of Acc. not compliant	-	Replace sign with a sign containing the International Symbol of Accessibility.	1	116	\$116
Toilet Rooms for Children

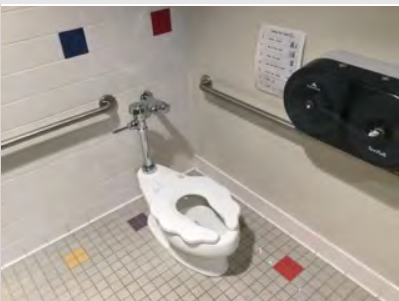
32	Kindergarten Toilet Room T110	1	T110	Single-User Toilet	N/A

Non-compliant toilet paper dispenser	-	Replace toilet paper dispenser that does not allow continuous paper flow. Relocate toilet paper so that it is 15" min. high, and located under the grab bar.	1	353	\$353

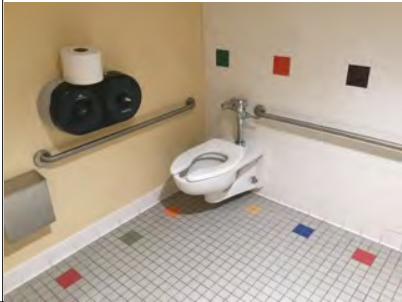
ID	Location	Floor	Room	Element	Type	Photo	Issues	Current Measure	Recommendations	Quantity	Price	Cost Estimation
Toilet Rooms for Children												
33	Toilet Room T112	1	T112	Single-User Toilet	N/A

Non-compliant toilet paper dispenser	-	Replace toilet paper dispenser that does not allow continuous paper flow. Relocate toilet paper so that it is 15" min. high, and located under the grab bar.	1	353	\$353
Best Practice												
34	Stairs	All			Stairs

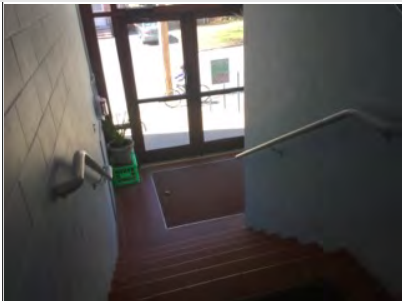
Emergency exit not on an accessible route Directional sign to accessible emergency exit not provided Tactile exit sign not provided	- -	Provide a directional sign indicating the location of the nearest emergency exit. Provide tactile exit signs with raised characters and braille at exit doors. Mount signs between 48" - 60" above the finished floor on the latch side of the door.	2	116	\$232

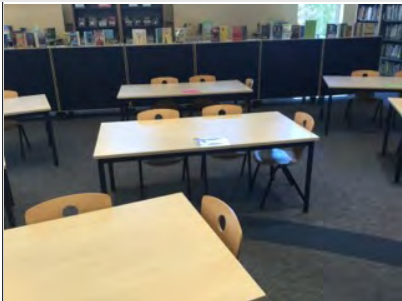
Access to Goods and Services												
36	Media Center	B		Dining or Work Surfaces	Work Surface

At least one or 5% accessible tables not provided	22"	Provide at least one (1) accessible table with 24" min. knee clearance and 30" min. clear width. Ensure accessible work surfaces are well integrated with class seating plans.	1	350	\$350

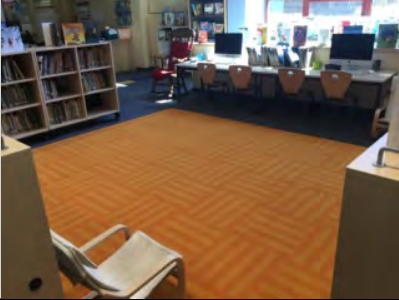
ID	Location	Floor	Room	Element	Type	Photo	Issues	Current Measure	Recommendations	Quantity	Price	Cost Estimation
37	Media Center	B		Interior Access Route	N/A

Surface not stable, firm, and slip-resistant	-	Secure the mat.	1	Labor	\$0
Approach and Entrance												
38	Exit in Stairwell 1	B	005	Emergency Exit	N/A

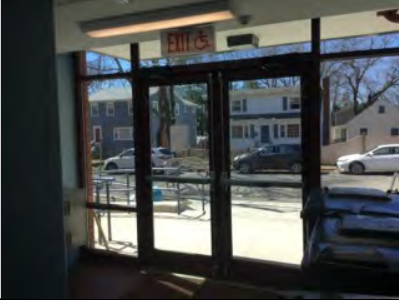
Tactile exit sign not provided	-	Provide tactile exit signs with raised characters and braille at exit doors. Mount signs between 48" - 60" above the finished floor on the latch side of the door.	1	116	\$116
Access to Goods and Services												
39	"A Place to Grow" Afterschool Program	B	010	Interior Access Route	N/A

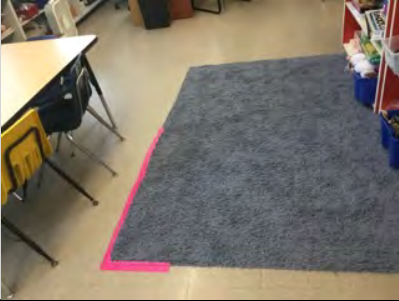
Surface not stable, firm, and slip-resistant	-	Secure the mat.	1	Labor	\$0
Access to Goods and Services												
40	3rd Grade Classroom	B	015	Signage	Designation

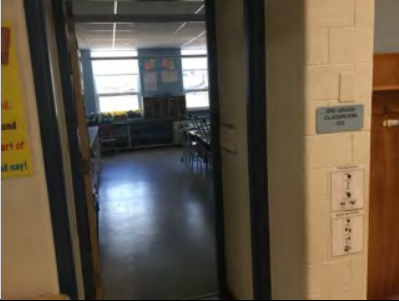
Sign not located on the latch side of the door	-	Locate sign at permanent rooms alongside the door on the latch side. Where there is no wall space at the latch side of a single door, signs shall be located on the nearest adjacent wall.	1	Labor	\$0

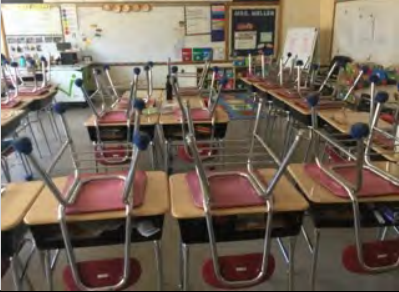
41	3rd Grade Classroom	B	015	Dining or Work Surfaces	Work Surface

At least one or 5% accessible tables not provided	-	Provide at least one (1) accessible desk with 24" min. knee clearance and 30" min. clear width. Ensure accessible work surfaces are well integrated with class seating plans.	1	350	\$350

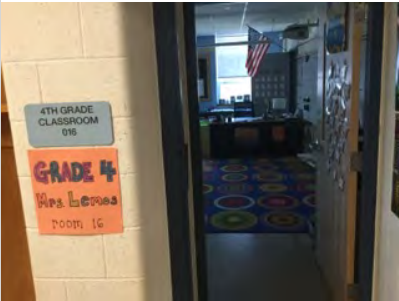
ID	Location	Floor	Room	Element	Type	Photo	Issues	Current Measure	Recommendations	Quantity	Price	Cost Estimation
Access to Goods and Services												
42	4th Grade Classroom	B	016	Signage	Designation

Sign not located on the latch side of the door	-	Locate sign at permanent rooms alongside the door on the latch side. Where there is no wall space at the latch side of a single door, signs shall be located on the nearest adjacent wall.	1	Labor	\$0
43	4th Grade Classroom	B	016	Dining or Work Surfaces	Work Surface

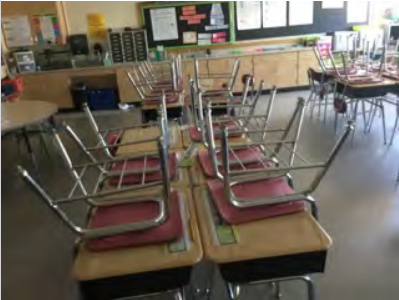
At least one or 5% accessible tables not provided	-	Provide at least one (1) accessible desk with 24" min. knee clearance and 30" min. clear width. Ensure accessible work surfaces are well integrated with class seating plans.	1	350	\$350
Access to Goods and Services												
44	5th Grade Classroom	B	021	Signage	Designation

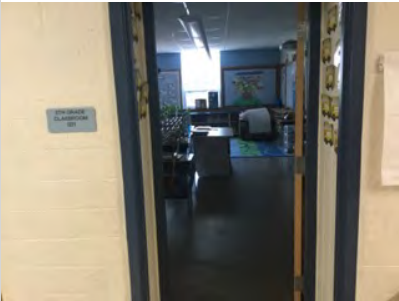
Sign not located on the latch side of the door	-	Locate sign at permanent rooms alongside the door on the latch side. Where there is no wall space at the latch side of a single door, signs shall be located on the nearest adjacent wall.	1	Labor	\$0

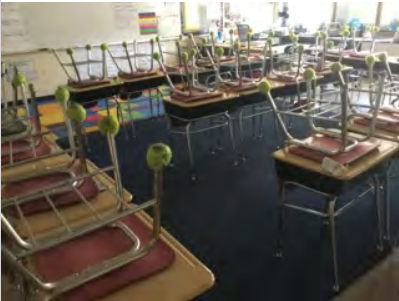
45	5th Grade Classroom	B	021	Dining or Work Surfaces	Work Surface

At least one or 5% accessible tables not provided	-	Provide at least one (1) accessible desk with 24" min. knee clearance and 30" min. clear width. Ensure accessible work surfaces are well integrated with class seating plans.	1	350	\$350
46	5th Grade Classroom	B	021	Interior Access Route	N/A

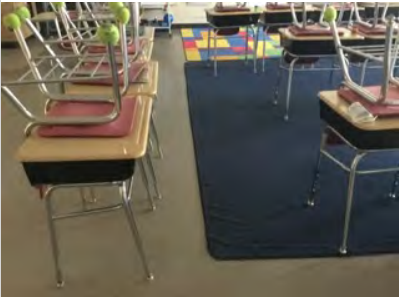
Surface not stable, firm, and slip-resistant	-	Secure the mat.	1	Labor	\$0

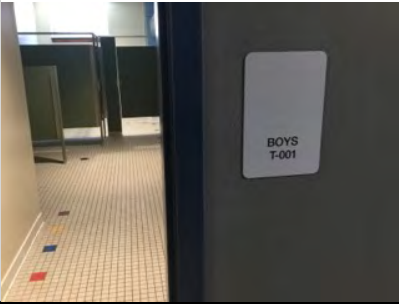
ID	Location	Floor	Room	Element	Type	Photo	Issues	Current Measure	Recommendations	Quantity	Price	Cost Estimation
Access to Goods and Services												
47	Toilet Room T001	B	T001	Signage	Designation

International Symbol of Acc. not compliant	-	Replace sign with a sign containing the International Symbol of Accessibility.	1	116	\$116
Toilet Rooms for Children												
48	Toilet Room T001	B	T001	Toilet Compartment	Accessible Compartment

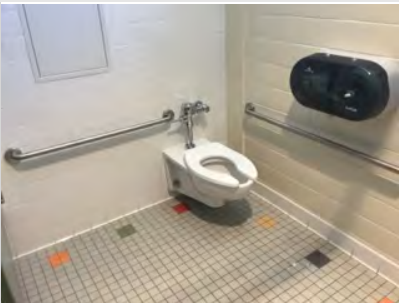
Non-compliant toilet paper dispenser	-	Replace dispenser that does not allow continuous paper flow. Relocate toilet paper so that it is 15" min. high, and located under the grab bar.	1	353	\$353
Access to Goods and Services												
49	Toilet Room T002	B	T002	Signage	Designation

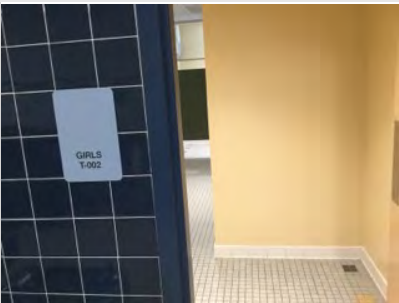
International Symbol of Acc. not compliant	-	Replace sign with a sign containing the International Symbol of Accessibility.	1	116	\$116
Toilet Rooms for Children

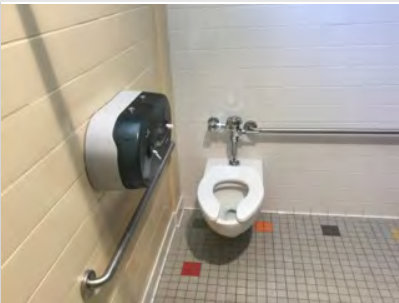
50	Toilet Room T002	B	T002	Toilet Compartment	Accessible Compartment

Non-compliant toilet paper dispenser	-	Replace toilet paper dispenser that does not allow continuous paper flow. Relocate toilet paper so that it is 15" min. high, and located under the grab bar.	1	353	\$353

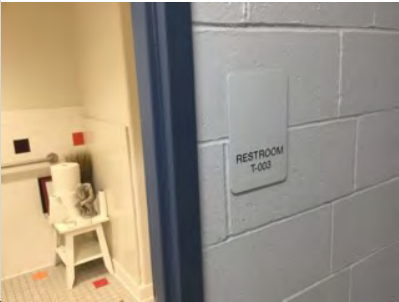
ID	Location	Floor	Room	Element	Type	Photo	Issues	Current Measure	Recommendations	Quantity	Price	Cost Estimation
Access to Goods and Services												
51	Toilet Room T003	B	T003	Signage	Designation

International Symbol of Acc. not compliant	-	Replace sign with a sign containing the International Symbol of Accessibility.	1	116	\$116
Toilet & Bathing Rooms												
52	Toilet Room T003	B	T003	Single-User Toilet	N/A

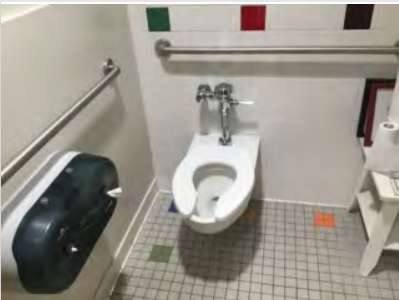
Clearance at toilet < 60" clear width Toilet paper dispenser is not compliant	- -	Remove or relocate table to provide 60" min. clearance beside toilet. Replace toilet paper dispenser that does not allow continuous paper flow.	1	353	\$353
Approach and Entrance												
53	Exit Near Media Center	B	T004	Emergency Exit	N/A

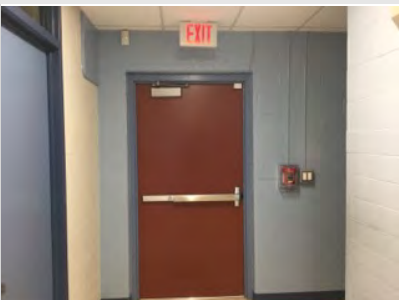
Emergency exit not on an accessible route Directional sign to accessible emergency exit not provided Tactile exit sign not provided	- -	Provide a directional sign indicating the location of the nearest emergency exit. Provide tactile exit signs with raised characters and braille at exit doors. Mount signs between 48" - 60" above the finished floor on the latch side of the door.	2	116	\$232

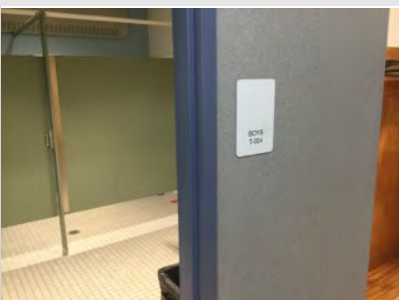
Access to Goods and Services												
54	Toilet Room T004	B	T004	Signage	Designation

International Symbol of Acc. not compliant	-	Replace sign with a sign containing the International Symbol of Accessibility.	1	116	\$116

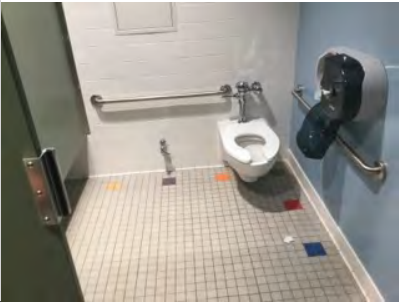
ID	Location	Floor	Room	Element	Type	Photo	Issues	Current Measure	Recommendations	Quantity	Price	Cost Estimation
Toilet Rooms for Children												
55	Toilet Rooms T004, T005	B	T004, T005	Toilet Compartment	Accessible Compartment

Non-compliant toilet paper dispenser	-	Replace toilet paper dispenser that does not allow continuous paper flow. Relocate toilet paper so that it is 15" min. high, and located under the grab bar.	2	353	\$706
Access to Goods and Services												
56	Toilet Room T005	B	T005	Signage	Designation

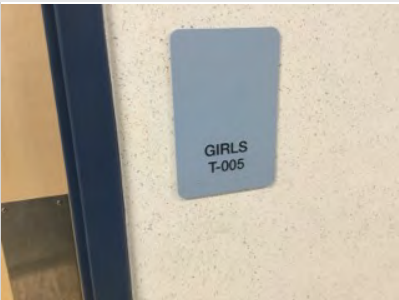
International Symbol of Acc. not compliant	-	Replace sign with a sign containing the International Symbol of Accessibility.	1	116	\$116
Access to Goods and Services												
57	Access Ramp to Playground	Ext.		Ramps

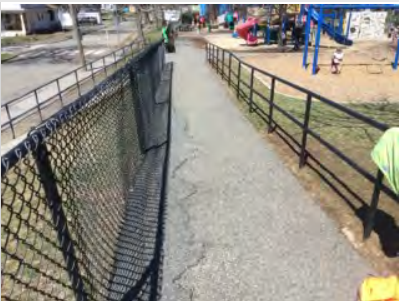
Handrails not provided at both sides if rise is > 6"	-	See recommendations from Recreation Department Self-Evaluation from 2014 for recommendations.	1	-	\$0

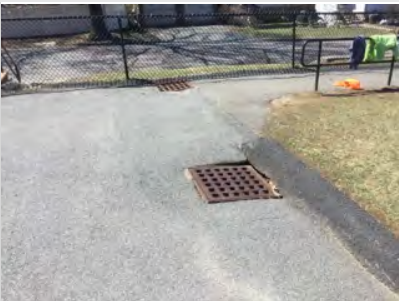
Approach and Entrance												
58	Access Route to Playground	Ext.		Exterior Access Route	Exterior

Surface openings > 1/2"	2"	Replace or reposition so that openings are 1/2" max. and the long opening dimension is perpendicular to the dominant direction of travel. (Cost estimate based on two new compliant drainage grates.)	2	1154	\$2308

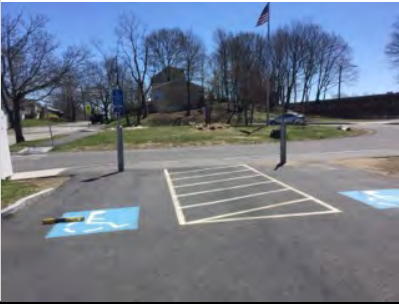
ID	Location	Floor	Room	Element	Type	Photo	Issues	Current Measure	Recommendations	Quantity	Price	Cost Estimation
Approach and Entrance												
59	Parking Lot	Ext.		Off-Street Parking Lot or Garage	N/A

Sign not provided Total # of parking Total # of designated accessible parking spaces Total # of designated van accessible spaces Sign does not have the designation "Van Accessible"	36 2 0 - -	Provide a sign with the International Symbol of Accessibility (ISA) with the bottom of the sign 60" min. above the ground and the top 96" max. above the ground at the accessible parking space where it is missing. Add the designation "Van Accessible" to the sign located at the van accessible space.	1	500	\$500
Access to Goods and Services												
60	Parking Lot	Ext.		Operable Parts	Bike Rack

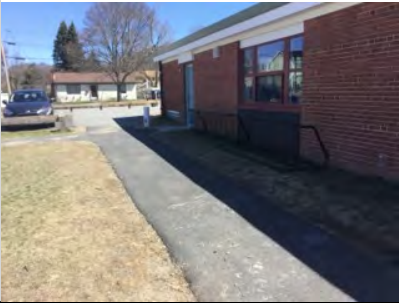
Element not on an accessible route	15'	Ensure bike rack is located on an accessible route. (Cost estimate based on installation of 15 ft. long, 4 ft. wide asphalt path.)	1	520	\$520

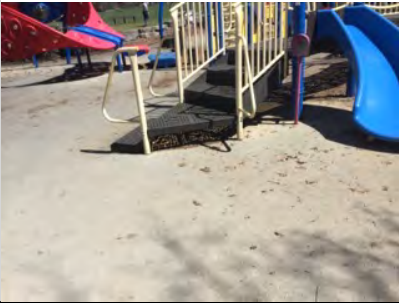
Play and Sport Areas												
61	Playground	Ext.		Play Areas	N/A

No compliant transfer system	-	Alteration might be technically infeasible until play component is replaced.	1	-	\$0
Best Practice												
62	Playground	Ext.			Stairs

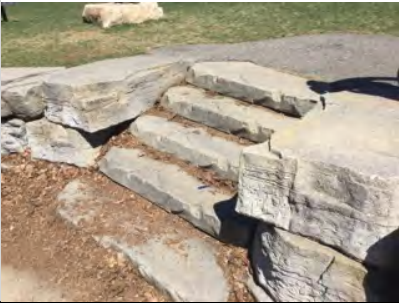
Best Practice		Best Practice: Consider renovating stairs to have accessible handrails with extensions and consistent treads and risers. Consider adding color-contrasting strips at each stair tread to improve access for people who are blind or low-vision.	1	-	\$0

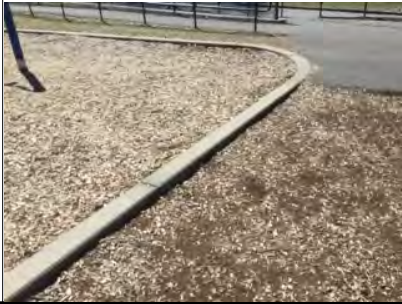
ID	Location	Floor	Room	Element	Type	Photo	Issues	Current Measure	Recommendations	Quantity	Price	Cost Estimation
Play and Sport Areas												
63	Playground Swings	Ext.		Play Areas	N/A

Accessible route not provided to play components	-	Provide an accessible route to the swings. (Cost estimate for an 85' long 5' wide poured-in-place rubber route to the swings.)	1	5950	\$5950
Best Practice												
64	Stairs to Court from Street	Ext.			Stairs

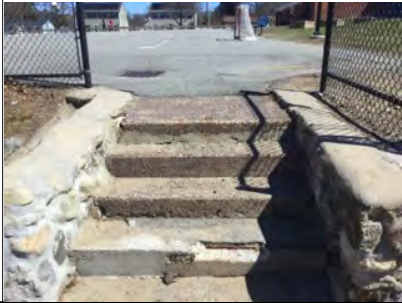
Best Practice		Best Practice: Consider renovating stairs to have accessible handrails with extensions and consistent treads and risers. Consider adding color-contrasting strips at each stair tread to improve access for people who are blind or low-vision.	1	-	\$0

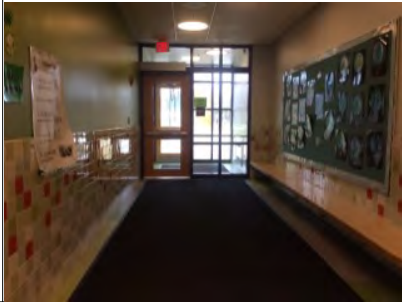
ID	Location	Floor	Room	Element	Type	Photo	Issues	Current Measure	Recommendations	Quantity	Price	Cost Estimation
Approach and Entrance												
1	Exit 11 (Labeled 9 on Plan)	1		Emergency Exit	N/A

International Symbol of Acc. not provided	-	Provide the International Symbol of Accessibility on the illuminated exit sign above the exit door.	1	116	\$116
Approach and Entrance												
2	Exit 12 in Main Lobby	1		Emergency Exit	N/A

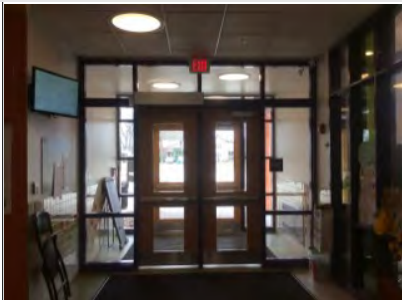
International Symbol of Acc. not provided	-	Provide the International Symbol of Accessibility on the illuminated exit sign above the exit doors.	1	116	\$116
Approach and Entrance												
3	Exit 14 Near 108 (Labeled 10 on Plan)	1		Emergency Exit	N/A

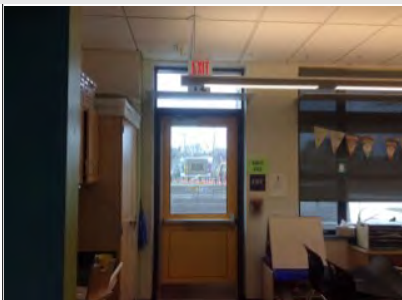
International Symbol of Acc. not provided	-	Provide the International Symbol of Accessibility on the illuminated exit sign above the exit door.	1	116	\$116
Approach and Entrance												
4	Exit 5	1		Emergency Exit	N/A

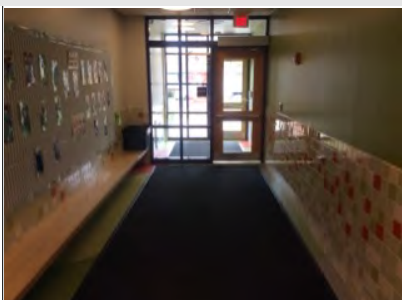
International Symbol of Acc. not provided	-	Provide the International Symbol of Accessibility on the illuminated exit sign above the exit door.	1	116	\$116

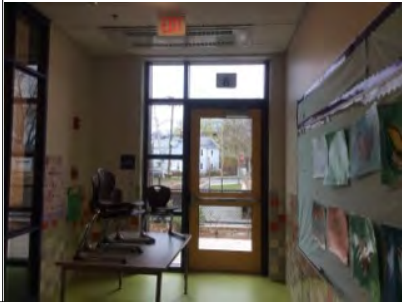
ID	Location	Floor	Room	Element	Type	Photo	Issues	Current Measure	Recommendations	Quantity	Price	Cost Estimation
Approach and Entrance												
5	Exit 8 Near A101	1		Emergency Exit	N/A

International Symbol of Acc. not provided	-	Provide the International Symbol of Accessibility on the illuminated exit sign above the exit door.	1	116	\$116
Approach and Entrance												
6	Main Entrance	1		Emergency Exit	N/A

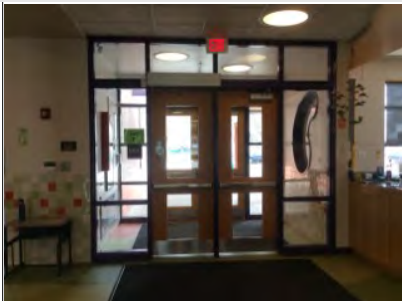
International Symbol of Acc. not provided	-	Provide the International Symbol of Accessibility on the illuminated exit sign above the exit doors.	1	116	\$116
Toilet & Bathing Rooms												
7	Single-User Toilet Rooms Near 108	1		Single-User Toilet	N/A

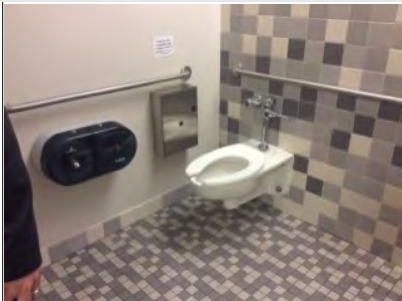
Toilet paper dispenser is not compliant	-	Replace toilet paper dispensers as they do not allow continuous paper flow.	2	353	\$706
8	Single-User Toilet Rooms Near 108	1		Dispensers	Paper Towel Dispenser

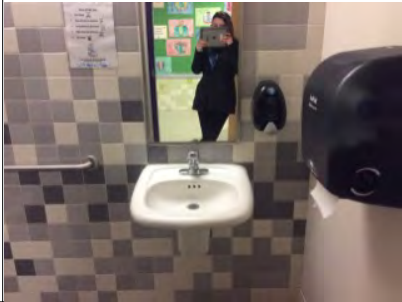
Dispenser acts as a protruding object	-	Relocate paper towel dispenser out of the circulation path.	2	353	\$706
